External Stress-Corrosion Cracking of a 1.22-m-Diameter Type 316 Stainless Steel Air Valve

Thomas J. Moore,
Jack Telesman,
Allan S. Moore,
Dereck F. Johnson,
and David E. Kuivinen
*Lewis Research Center
Cleveland, Ohio*

Summary

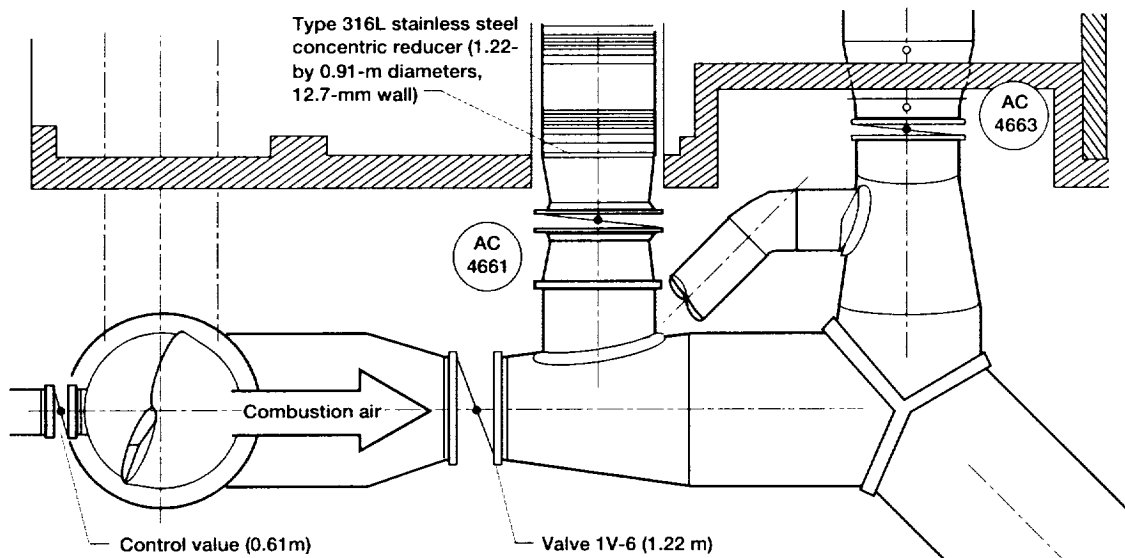
The outdoor pipeline immediately upstream and downstream from the failed 1V-6 valve is shown in figure 1. Valve 1V-6 is used in various modes to blend and divert combustion air to altitude test chambers in an adjacent building. These chambers are used in the testing of full-size aircraft turbine engines.

Figure 1.—A portion of the plan drawing of the outdoor air supply system. Cracking occurred at valve 1V-6.

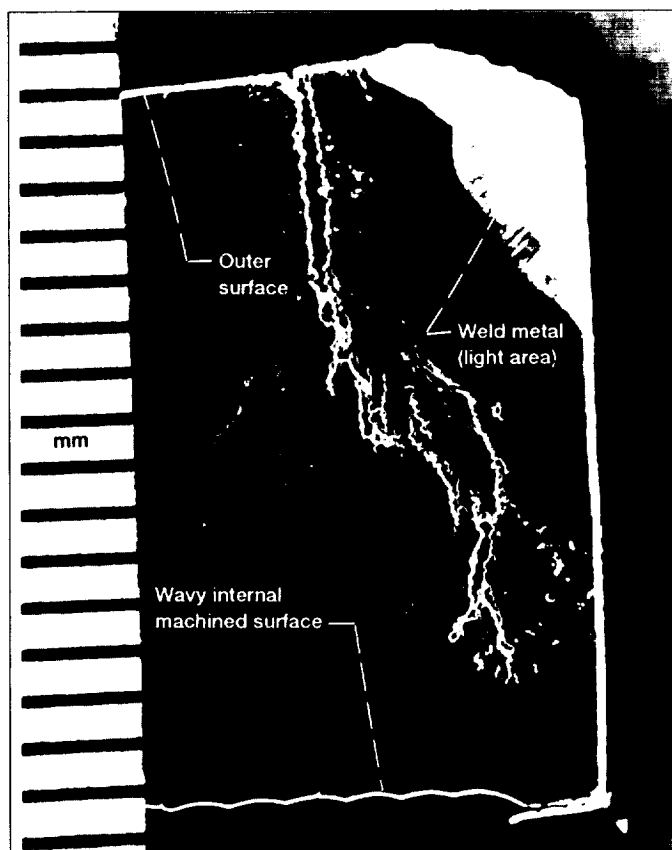
Plug specimens X and Y both separated into two pieces because at these locations the butt joint crack extended through the full thickness of the skirt. For specimen W, the crack did not penetrate completely through the skirt wall. It is

Figure 10.—Macrograph of stress-corrosion cracking in the heat-affected zone of a circumferential butt joint in Type 316 stainless steel (specimen W).

evident from the cracking pattern shown in figure 10 that the crack started at the outer surface of the skirt. Below the surface, it became branched. Figures 11(a) and (b) illustrate the intergranular nature of the cracking.

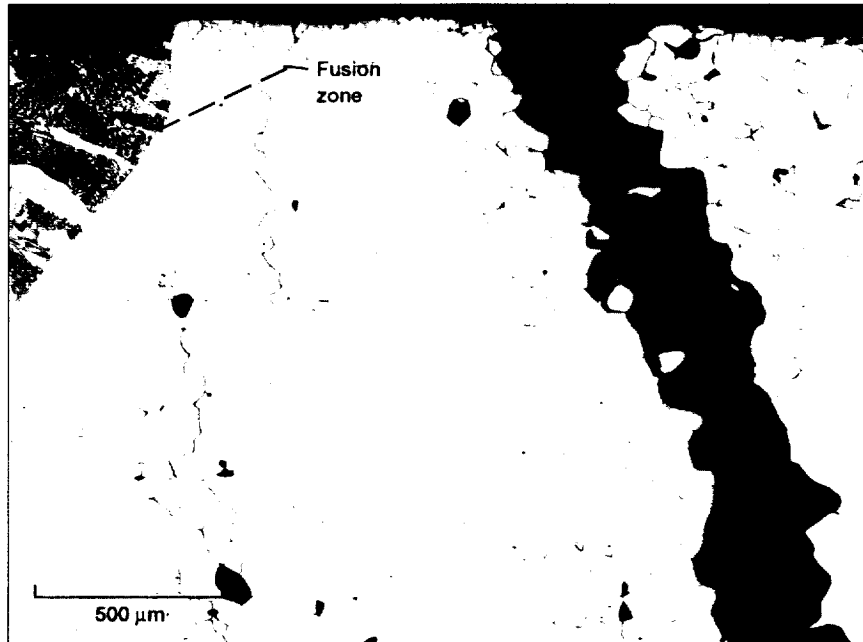
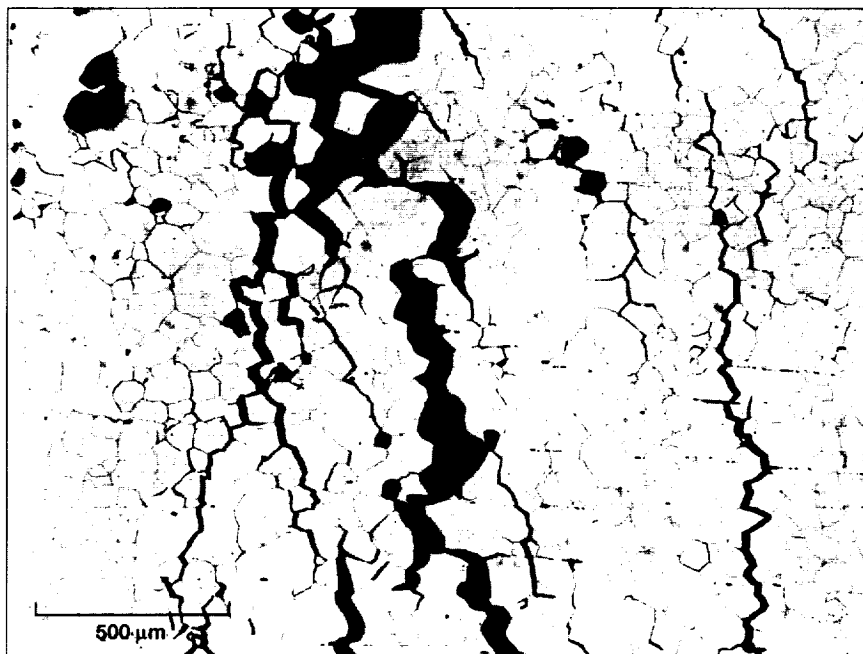
Figure 11.—Intergranular nature of the stress-corrosion cracking in the heat-affected-zone of the circumferential butt joint (specimen W).

(a) Intergranular, heat-affected-zone crack at outside surface.

(b) Intergranular, base metal cracks at midthickness of the skirt. The cracks are oriented roughly parallel to the main fracture path.

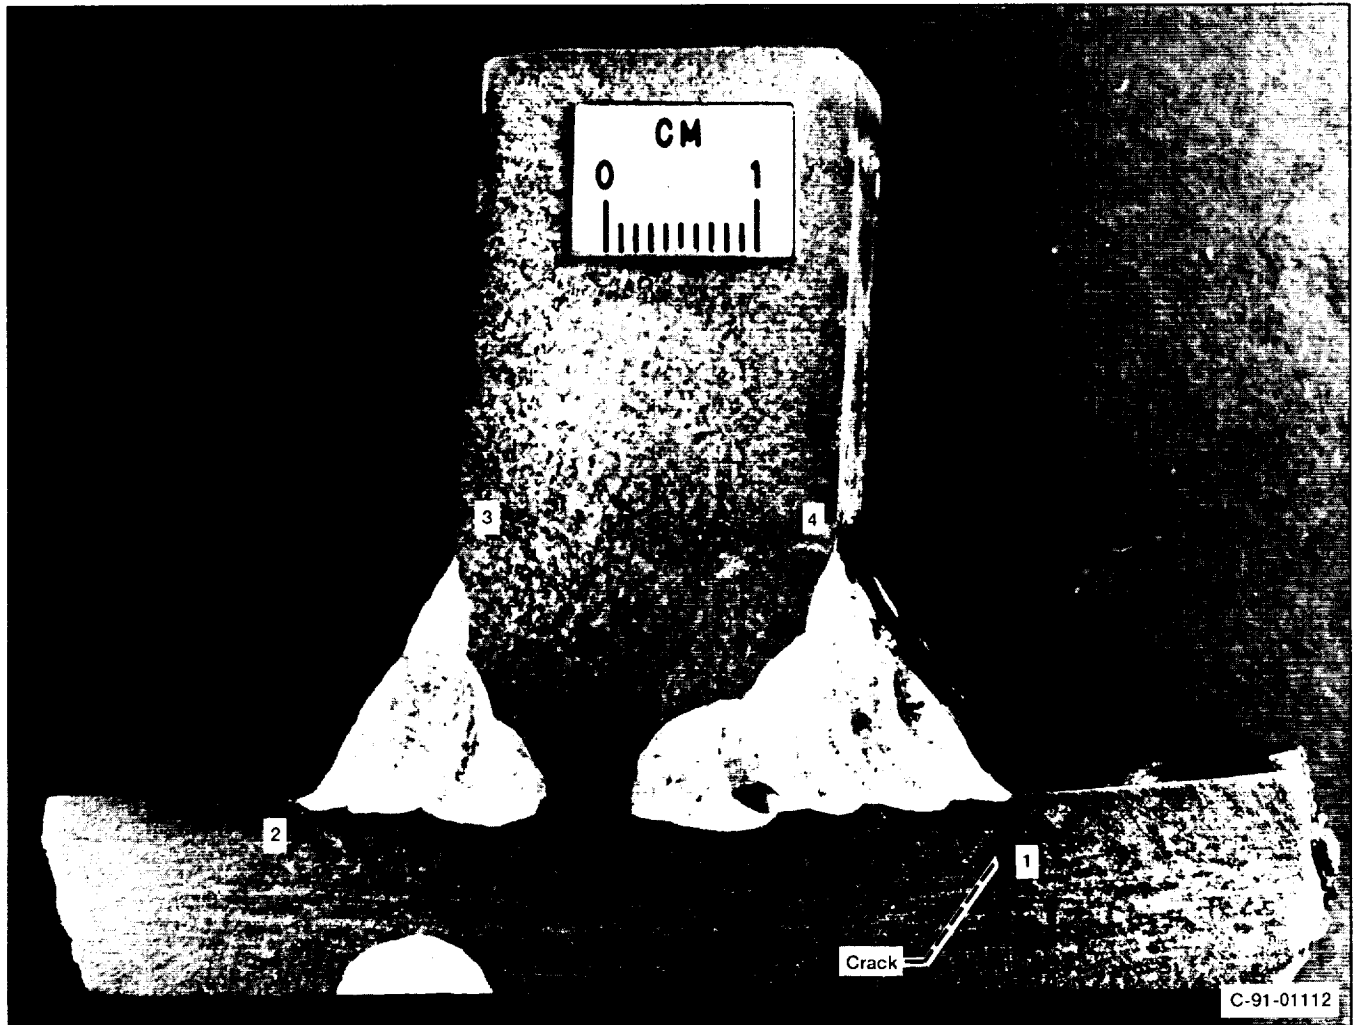
The cross section of sample Z from the valve skirt (fig. 12) shows a toe crack which extended more than half-way through the wall (location 1). Other cross sections of

Figure 12.—A cross section of sample Z T-joint showing a stress-corrosion toe crack in the Type 316 stainless steel valve skirt. Intergranular toe cracks (not evident in this photograph) are also present at locations 2, 3, and 4.

sample Z revealed that this crack had penetrated completely through the skirt for a distance of 18 cm along the circumference. Like the butt joint crack, it was narrow at the outer surface and branched as it proceeded towards the interior. The failure was intergranular, similar to that shown in figure 11. Tight, intergranular toe cracks not evident in figure 12 were present at locations 2, 3, and 4. These cracks were found only after sectioning and polishing. The cracking in the skirt at location 2 in figure 12 (shown in fig. 13(a)), extends to a depth of about 7 mm. At location 4 in figure 12, the cracking has progressed into the support ring to a depth of about 8 mm (see fig. 13(b)). At location 3 in figure 12, the cracking was only about 2 mm deep (not shown). The purpose of the autogenous gas tungsten arc weld pass at location 2 in figure 12, on the inner surface of the skirt, is not known.

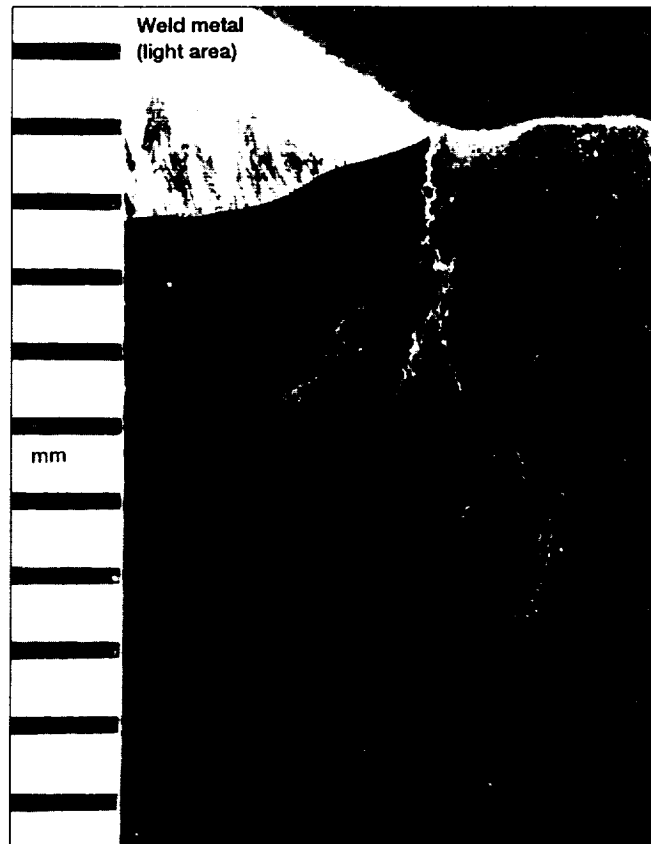
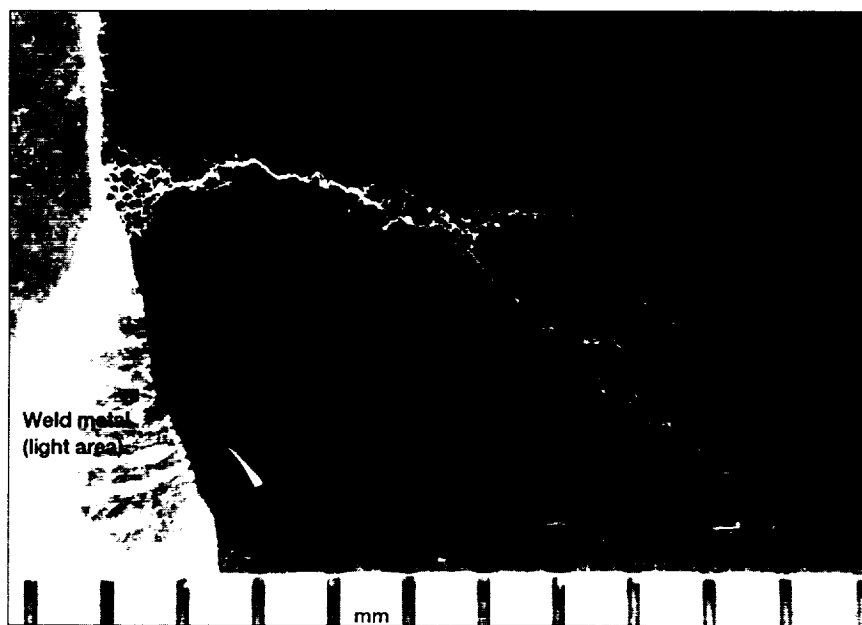
Figure 13.—Intergranular, stress-corrosion cracking at a T-joint in the Type 316 stainless steel valve.

(a) Cracking in the valve skirt at location 2 in figure 12.

(b) Cracking in the support ring at location 4 in figure 12.

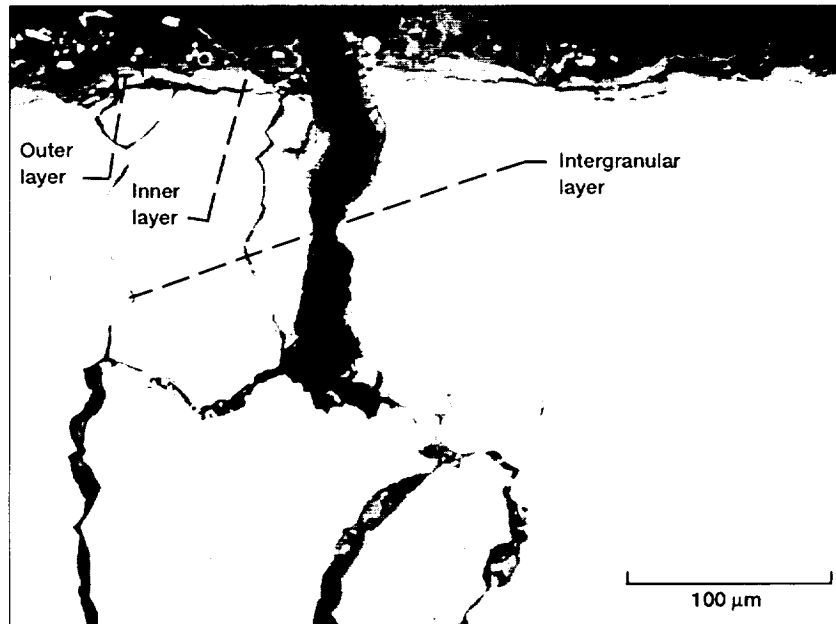
The support ring base metal toe crack at location 4 (fig. 13(b)) was the area examined. As shown in figure 14, two oxidelike layers were present at the outside surface, and a number of intergranular cracks extended from this surface into the support ring. The XEDS analysis was performed in three regions designated the outer layer, the inner layer, and the intergranular layer, respectively (fig. 14). XEDS analysis of the support ring was also conducted in a noncorroded area away from the crack.

Figure 14.—Backscatter scanning electron microscope image showing intergranular, stress-corrosion cracking and the locations that were analyzed.

A major difference in composition between the outer layer (fig. 14) and the support ring can be noted in the XEDS analysis in table I. First, the relative levels of chromium (Cr) and nickel (Ni) in the outer layer are significantly lower. Second, the outer layer appears to contain substantial quantities of chlorine (Cl), Ca, Si, and phosphorus (P). The Ca and Si indications are probably a result of plastic mounting material infiltration. But the presence of Cl, P, and possibly K are believed to result from the environment in which the valve operated. Analysis of the inner layer (shown in table I) indicates that this material is essentially Type 316 stainless steel.

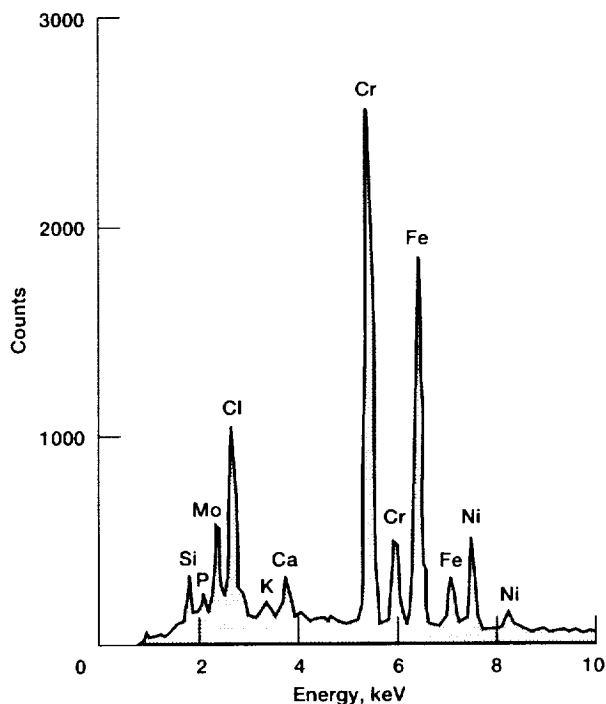
Perhaps the most important information was obtained from the analysis of the intergranular layer, 150 μm below the surface of the cracked ring (fig. 14). The profile for this spectra is shown in figure 16. These data are given in table I. A comparative XEDS analysis of the base metal and the intergranular layer showed increased quantities of Cr (18.5 to 31.1 percent), Cl (0.1 to 7.9 percent), and P (0.4 to 1.3 percent). The high Cr indicates the presence of chromium carbides at the grain boundaries (i.e., a sensitized condition). In this condition, the grain boundary regions adjacent to the

carbide particles are low in Cr and are thus susceptible to corrosive attack. The presence of a relatively large quantity of Cl is significant because of the key role this element plays in stress-corrosion cracking (SCC). The indicated increases in P and K may have resulted from the operational environment. Indications of higher Ca and Si are believed to be spurious, probably resulting from the plastic mounting material.

Figure 16.—Intergranular, stress-corrosion crack spectra.
